# GASOLINE PIPELINE RUPTURE AND EXPLOSION AT WHATCOM CREEK: A FOCUS ON RESPONSE MANAGEMENT

**ABSTRACT:** *Safety for the public and responders was the first priority in responding to the estimated 231,000 gallons unleaded gasoline release and explosion that killed three boys in Whatcom Park in Bellingham, Washington and devastated the environment. Establishment of the Unified Command structure was critical to manage the vast resources and multitude of issues that arose in the wake of the release to Hannah and Whatcom Creeks on June 10, 1999. The pollution response, investigations, infrastructure rebuilding, natural resource (trustee) restoration, and community outreach/public information were completed with funds from the potentially responsible party (PRP), Olympic Pipe Line (OPL), as mandated by the Oil Pollution Act of 1990. Goals evolved as projects changed from fire and explosion emergencies to time critical environmental emergencies. Bellingham's drinking water capacity was restored, and initial restoration of the creeks was completed in time for the August salmon runs. Ongoing activities include the operation and maintenance of a vapor extraction plus a ground water interce

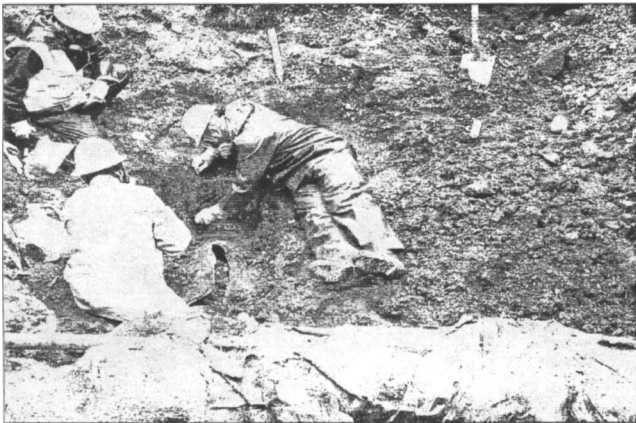
NTSB continues (as of November 2000) to evaluate the case, and results may be released within a year. The pipe was removed under direction of NTSB (Figure 2). NTSB appointed a still photographer (a fireman trained in hazardous materials response) and an EPA contractor for video photographs. The excavation and pipe removal was completed 18 days after the explosion.

Figure 2. Crews work to forensically uncover ruptured pipeline.

Two sections of pipe, including a rupture measuring 28 inches long by 7 inches wide and a relief valve from the Bayview terminal, were forensically removed and transported to NTSB, Washington, D.C. Pipeline operations and procedures at the OPL Renton headquarters were reviewed. The supervisory control and data acquisition system (SCADA) computer data also were reviewed. The record of actions taken prior to and after the release is based

on these reviews. Pipeline operators refused to talk to NTSB. The blowout in the 16-inch "312" (0.312 inches thick) steel buried pipe occurred at a location below a 72-inch water pipe plus a 24-inch to 16-inch valve "T" connection and immediately adjacent to a water pump vault. Other numerous subsurface pipes, chemical treatment lines buried telephone lines and the Dakins-Yew water pump vault were in the vicinity of the pipe break which complicated the investigation dig.

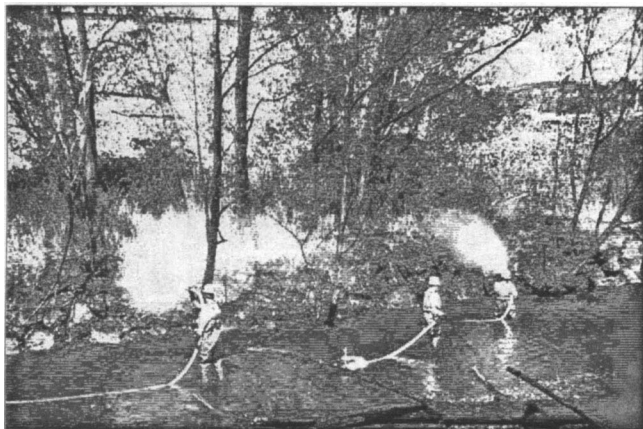
A crew of 75 local laborers was hired and hazardous materials trained. Silt fences were installed, and crews with float-a-pumps washed down the streambanks. Crews and heavy equipment were used to agitate creek bed sediments to release gasoline trapped in the sediments under the creeks. Figure 3 shows a crew washing the stream bank and streambed.

Figure 3. Float-a-pumps used low pressure to wash the banks and high pressure to spray streambeds.

Over several weeks, crews agitated the sediments by walking and jostling rocks with shovels and slam bars that released the gasoline from the sediments. After four manual-crew passes up and down the creeks, two track-hoes and a spyder-hoe worked the sediments and boulders to agitate sediments to depths of up to 2 feet below the creek bottom. During daily operations, the creek flow was reduced at the Whatcom Lake floodgates and following the daily sediment reworking, the creek level was raised 1–2 feet to flush Whatcom Creek for about 12 hours over night.

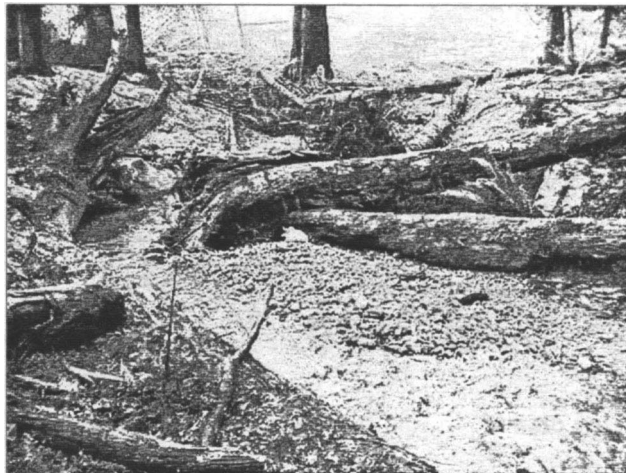
Figure 4. Hannah Creek, December 1999, shows creek reconstruction with logs, jute, and gravel placed to restore fish habitat.

Hannah Creek was removed, including the creek bed and banks where gasoline saturated up to 5 feet into the banks. The creek was dammed and bypassed through a pump and an 8-inch PVC pipe to Whatcom creek. An excavator removed over 1,200 feet of the creek bed and banks. Sheen (gold pan) tests were used to determine the extent of contamination as the excavator removed the bed and banks. Gasoline penetrated into gravel stringers and bank mats up to five feet from the original creek side. Surveys prior to removal were used to resurvey back the elevations and locations of the creek. The creek was backfilled with glacial gravel tills. Trees, jute mats, gravel, and boulders were placed to groom the “Hannah Highway” back to Hannah Creek. Water was rerouted back into the creek prior to the winter flood level rain season. Hannah Creek is shown in Figure 4 in December 1999. The picture illustrates creek reconstruction with logs, jute, and gravel placed to restore fish habitat. Figure 5 shows a picture of Whatcom creek, also in December 1999, illustrating a pool reconstruction area.
